INDOOR AIR QUALITY ASSESSMENT

**James L. Mulcahey Middle School
28 Clifford Street
Taunton, Massachusetts**

Prepared by:
Massachusetts Department of Public Health
Bureau of Environmental Health
Indoor Air Quality Program
March 2008

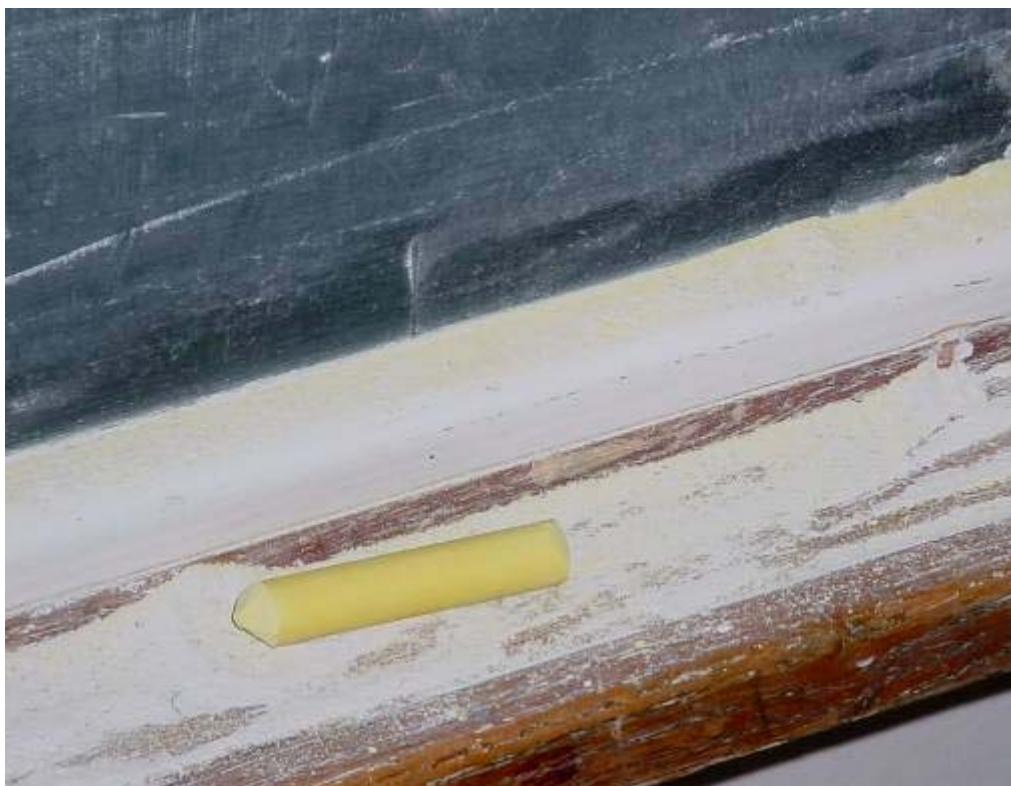
Picture 28

in occupied areas and subsequently be re-aerosolized causing further irritation. Accumulated chalk dust and dry erase particulate were noted in some classrooms (Pictures 28).

Accumulated Chalk Dust

15. Clean chalk and dry erase board trays to prevent accumulation of materials.
16. Identify and remediate cabinet material along exterior wall in wood shop in conformance with Massachusetts asbestos remediation and hazardous waste disposal laws (if necessary).

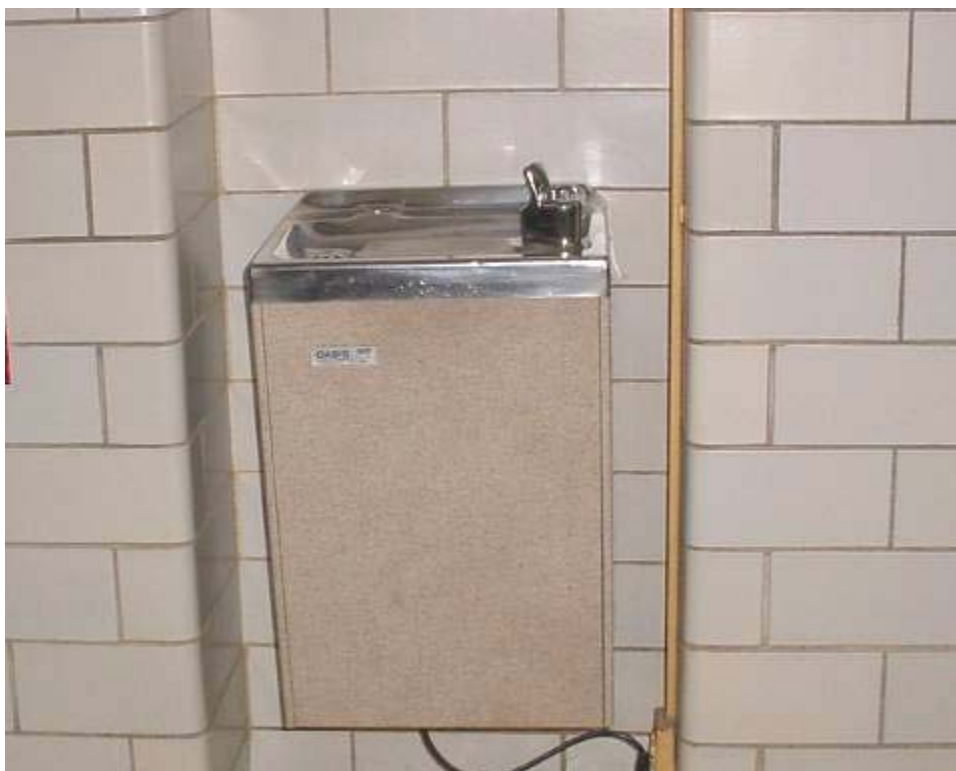
Picture 29

Musty odors were detected by BEH staff in the 2nd floor hallway. The source of the odors appeared to be from a non-functional/abandoned water fountain (Picture 29). Water fountains contain drains that are designed with traps in order to prevent sewer odors/gases from penetrating into occupied spaces. When water enters a drain, the trap fills and forms a watertight seal. Without a periodic input of water (e.g., every other day), traps can dry, breaking the watertight seal. Without a watertight seal, odors or other material can travel up the drain and enter the occupied space.

Non-Functional/Abandoned Water Fountain, 2nd Floor Hallway

18. Repair, remove or cap abandoned water fountain on 2nd floor; or ensure water is poured into the drain every other day (or as needed) to maintain the integrity of the trap.

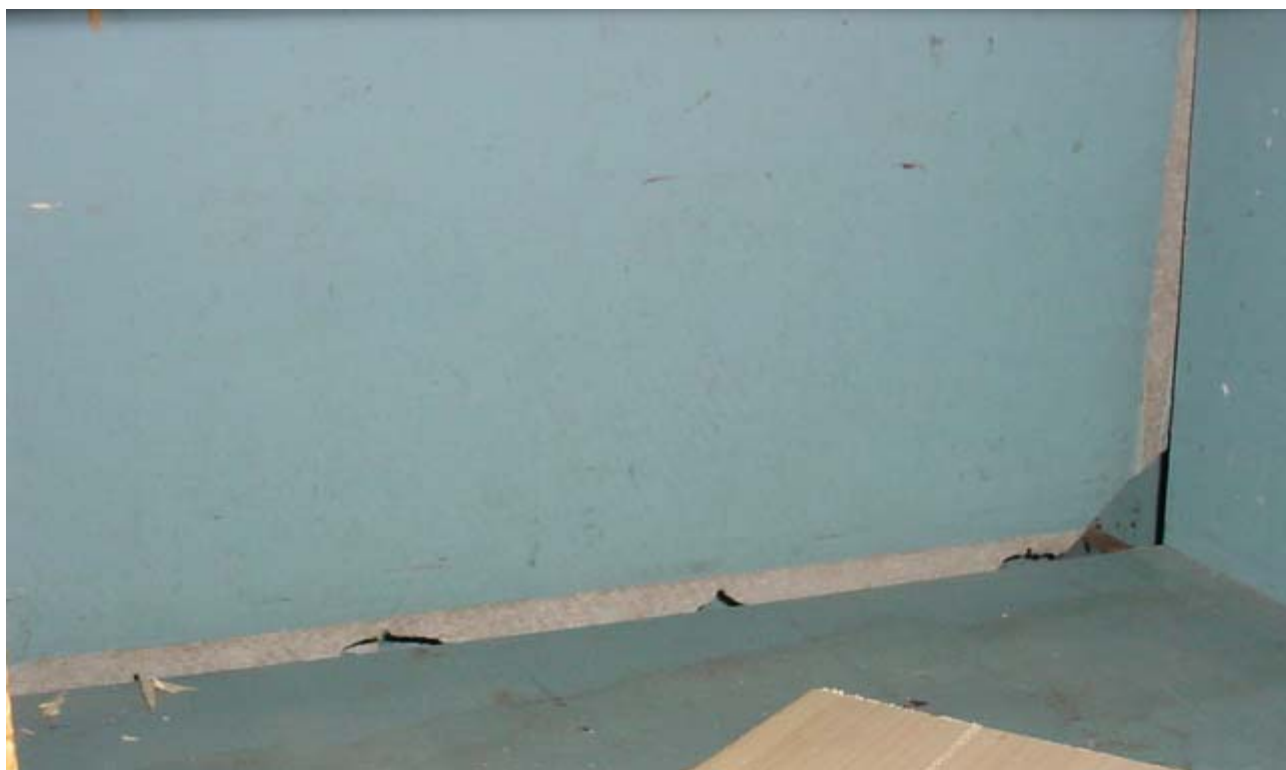
Picture 30

Finally, occupants had concerns regarding damaged building materials that make up cabinets along the exterior wall of the wood shop (Picture 30). The material was not labeled therefore it was unclear whether it contained asbestos. At the time of the assessment, BEH staff recommended that the material be identified and if found to contain asbestos, be remediated in conformance with Massachusetts asbestos remediation and hazardous waste disposal laws.

Damaged Cabinet Material in Wood Shop
